URGENT MEDICAL DEVICE SAFETY NOTICE AND CORRECTION

LIFEPAK® CR2 Defibrillator

January 22, 2021

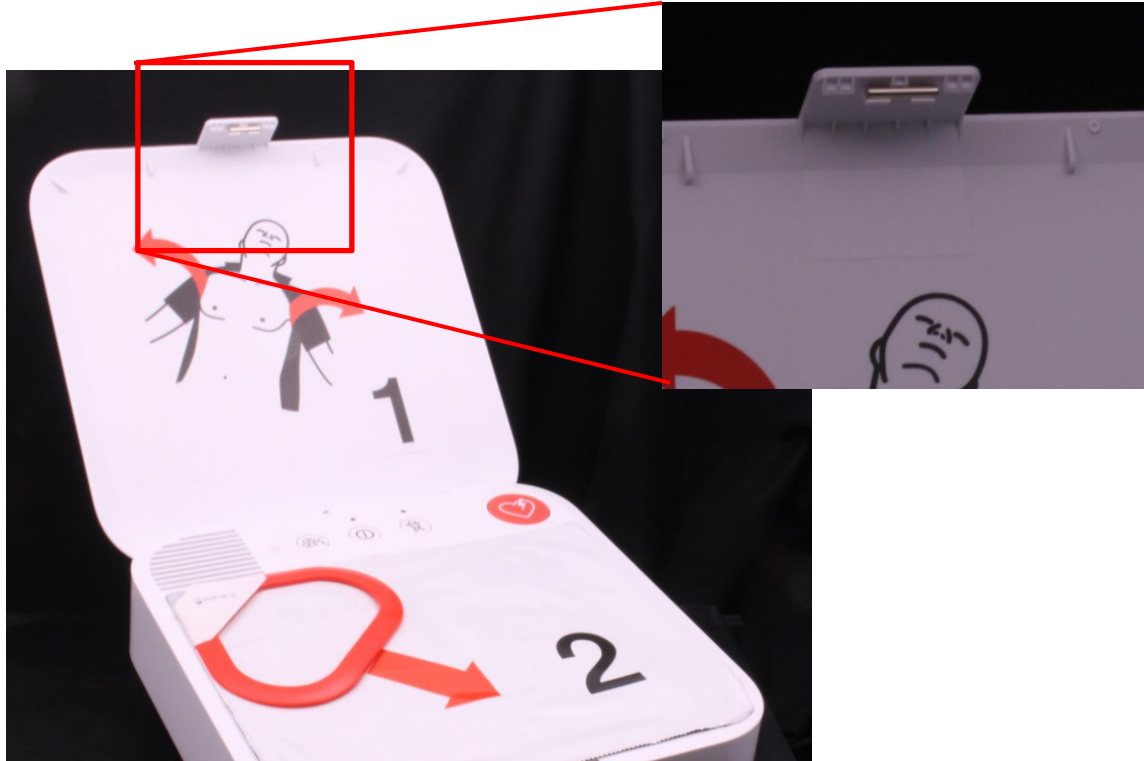
1. Open the LIFEPAK CR2 lid
2. Inspect lid magnet clip for presence of magnet as shown in figure below
