URGENT MEDICAL DEVICE SAFETY NOTICE AND CORRECTION

LIFEPAK® CR2 Defibrillator

January 22, 2021

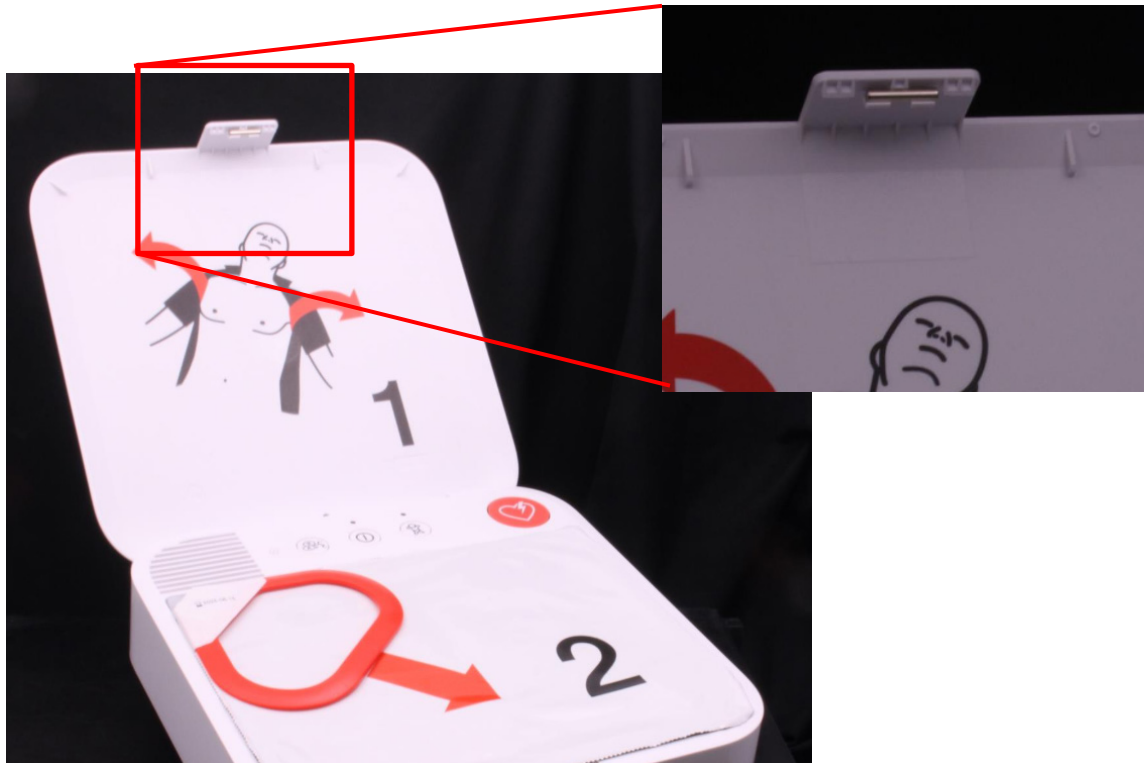
Lid Magnet Inspection Instructions

1. Open the LIFEPAK CR2 lid
2. Inspect lid magnet clip for presence of magnet as shown in figure below
